CONSTRUCTION STORMWATER GENERAL PERMIT INSPECTION REPORT

State of Washington Department of Ecology

The Electron Hydro LLC Intake project is covered under the State of Washington's Construction Stormwater General Permit (CSWGP). The CSWGP is a National Pollutant Discharge Elimination System (NPDES) and a State Waste Discharge permit for discharge of construction-related stormwater. Carol Serdar had previously been to the site a few years' prior, during the JARPA review for the then proposed construction of the barrier dam and intake structure.

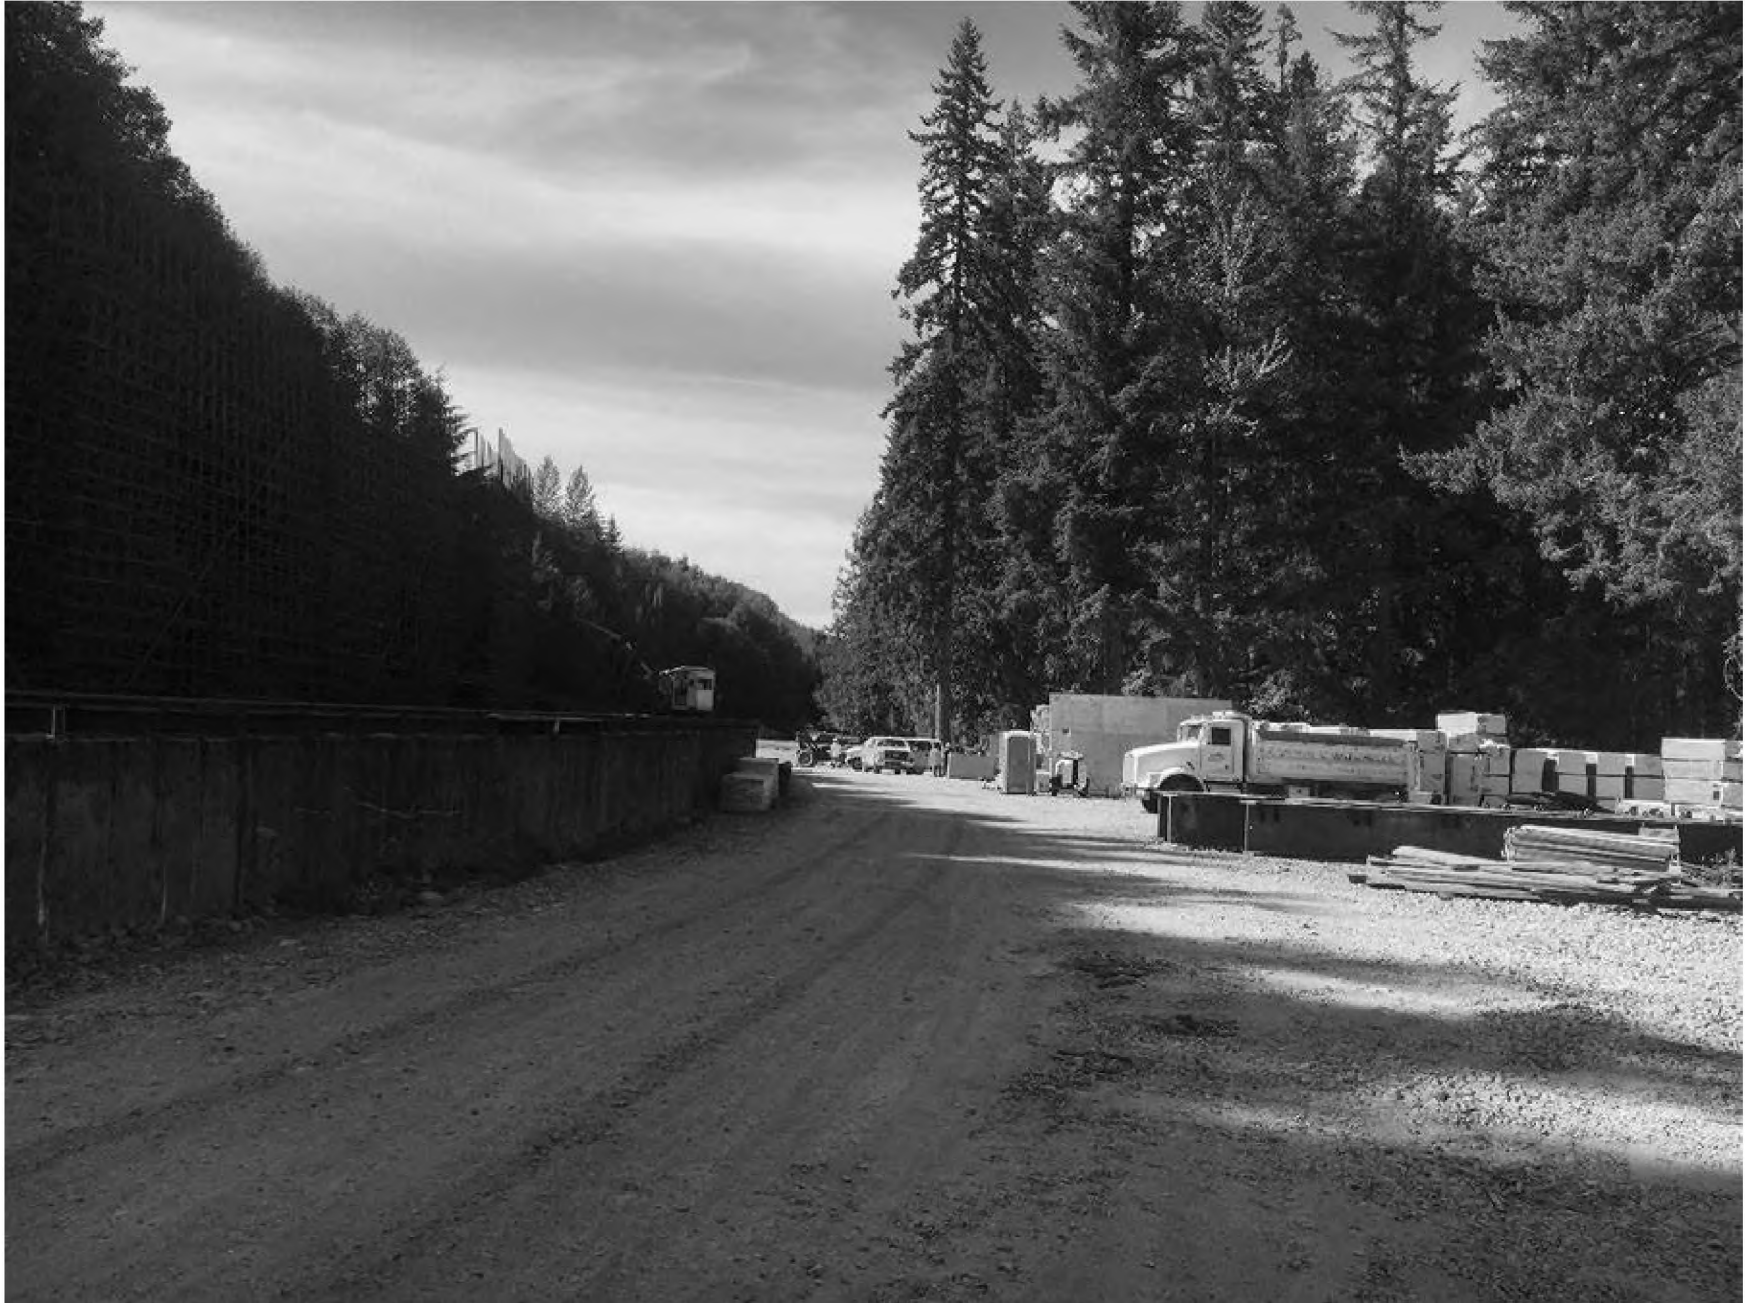
Photo 16

Photo Description: Haul road on left bank of river, staging area for flume construction.

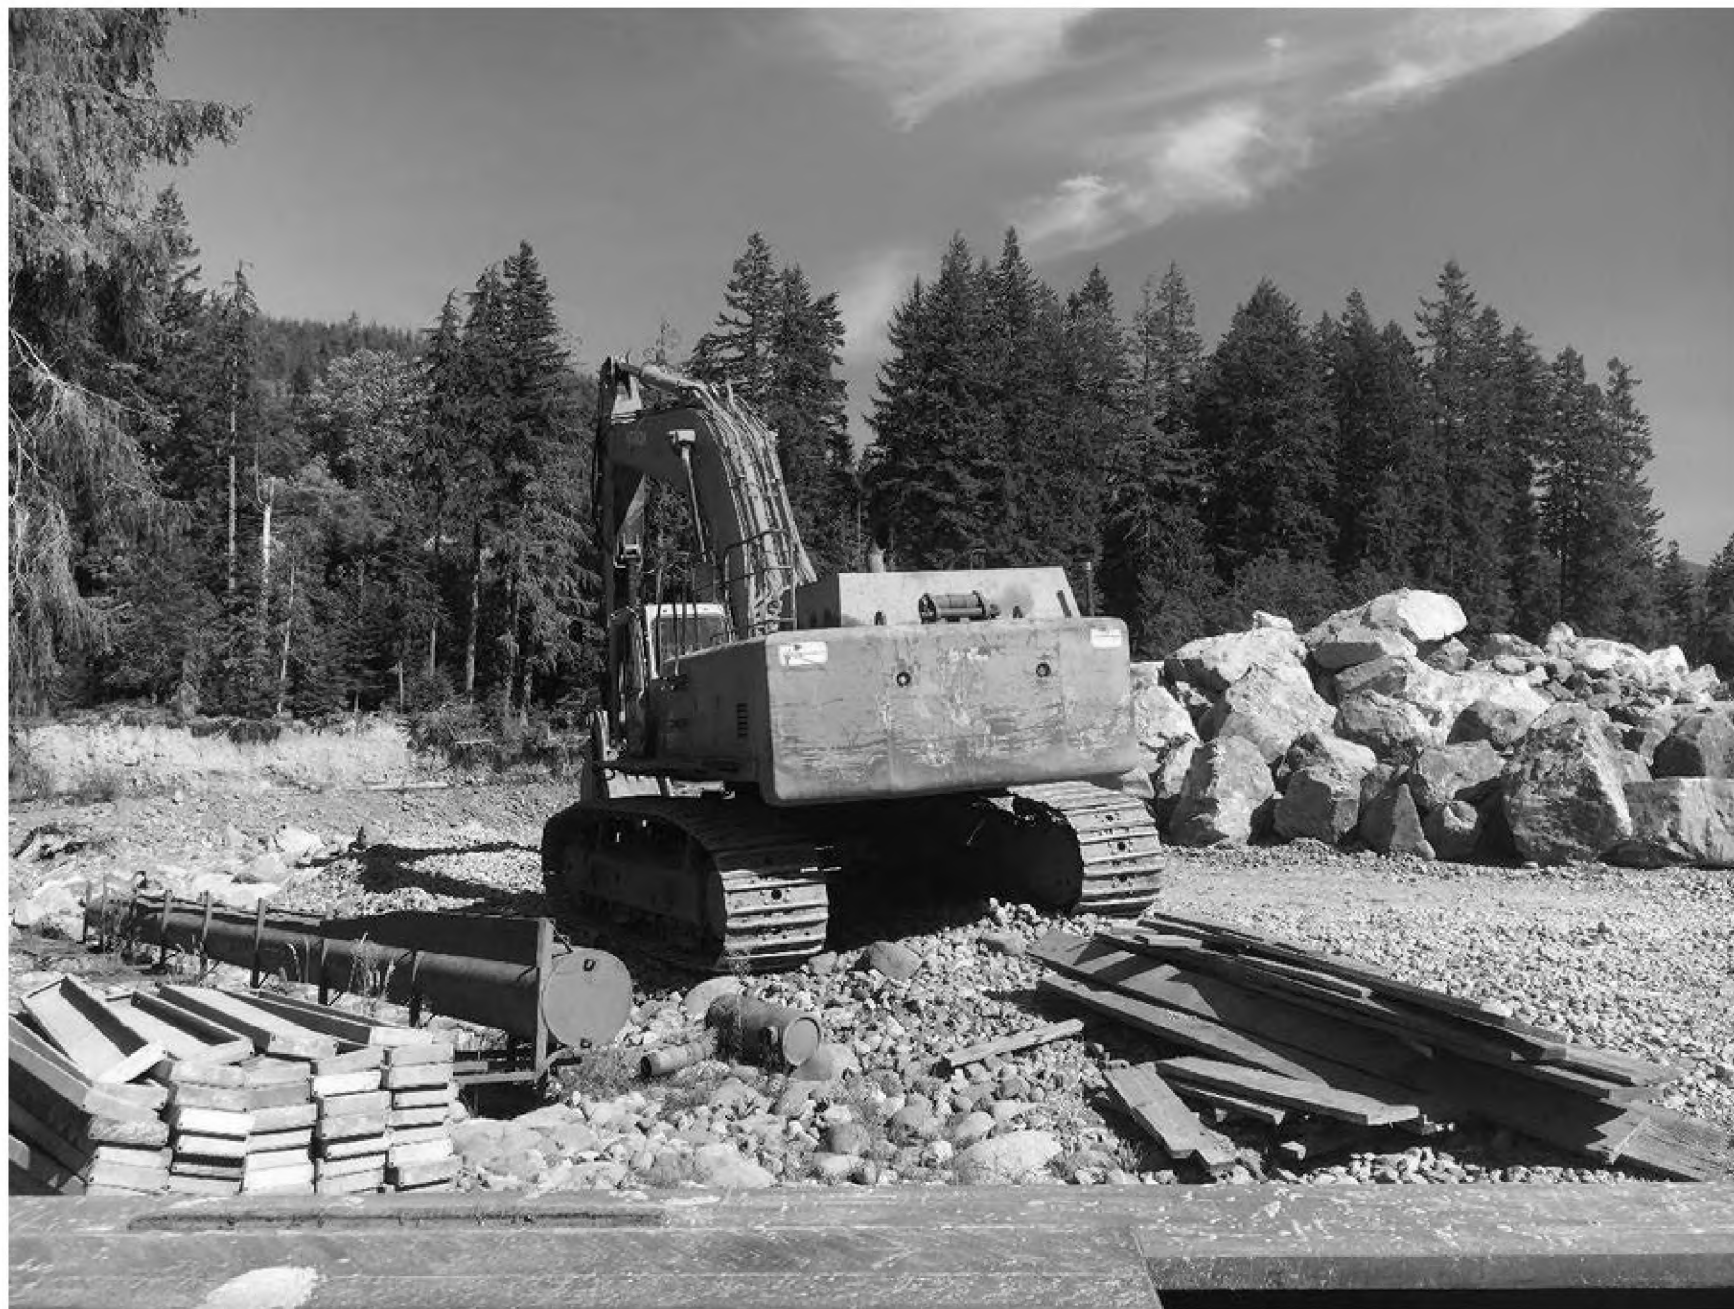
Photo 17

Photo Description: Equipment is checked for leaks at beginning and end of work day.

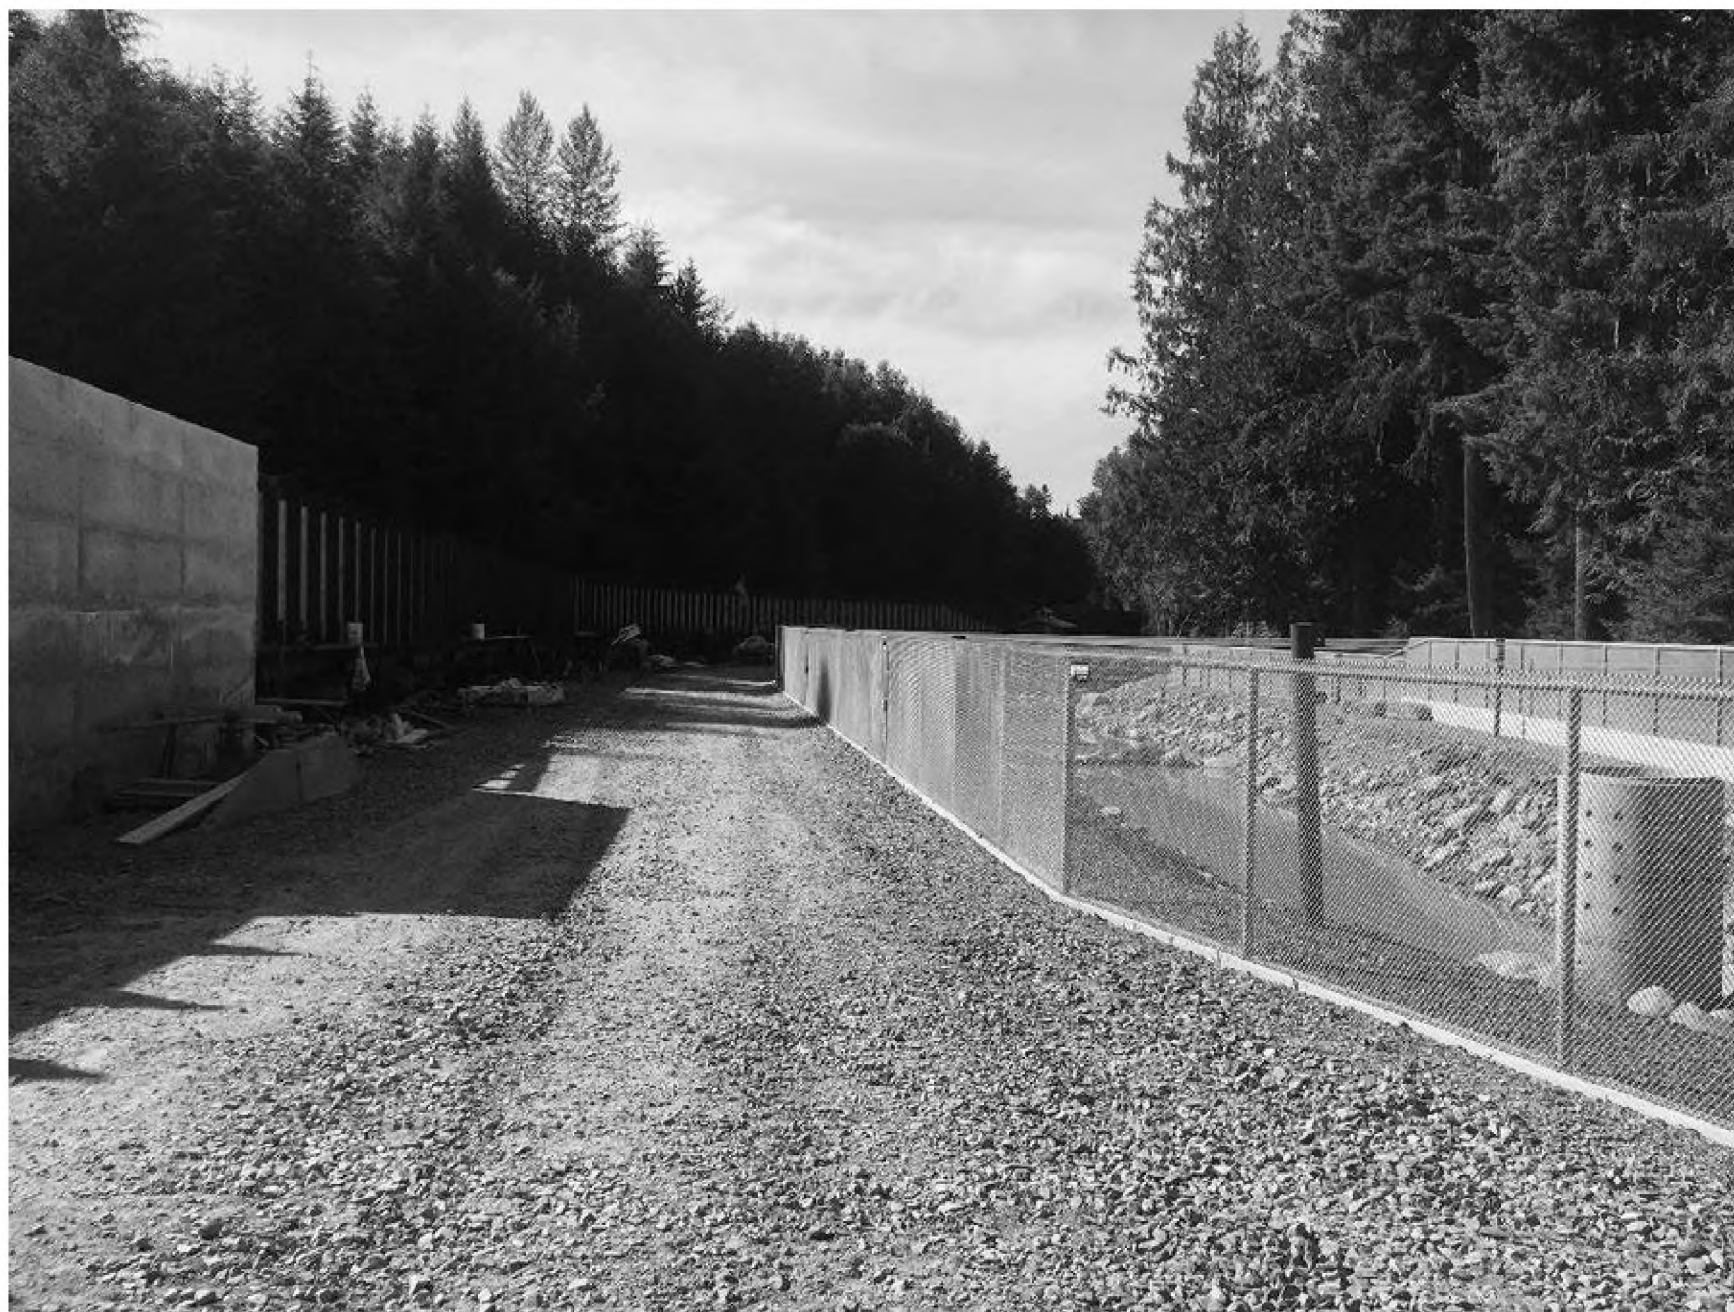
Photo 18

Photo Description: Stormwater pond (potentially a future acclimation pond for salmonids). Water enters this stormwater pond after traveling along the conveyance ditch, into the sediment pond (Photo 19).

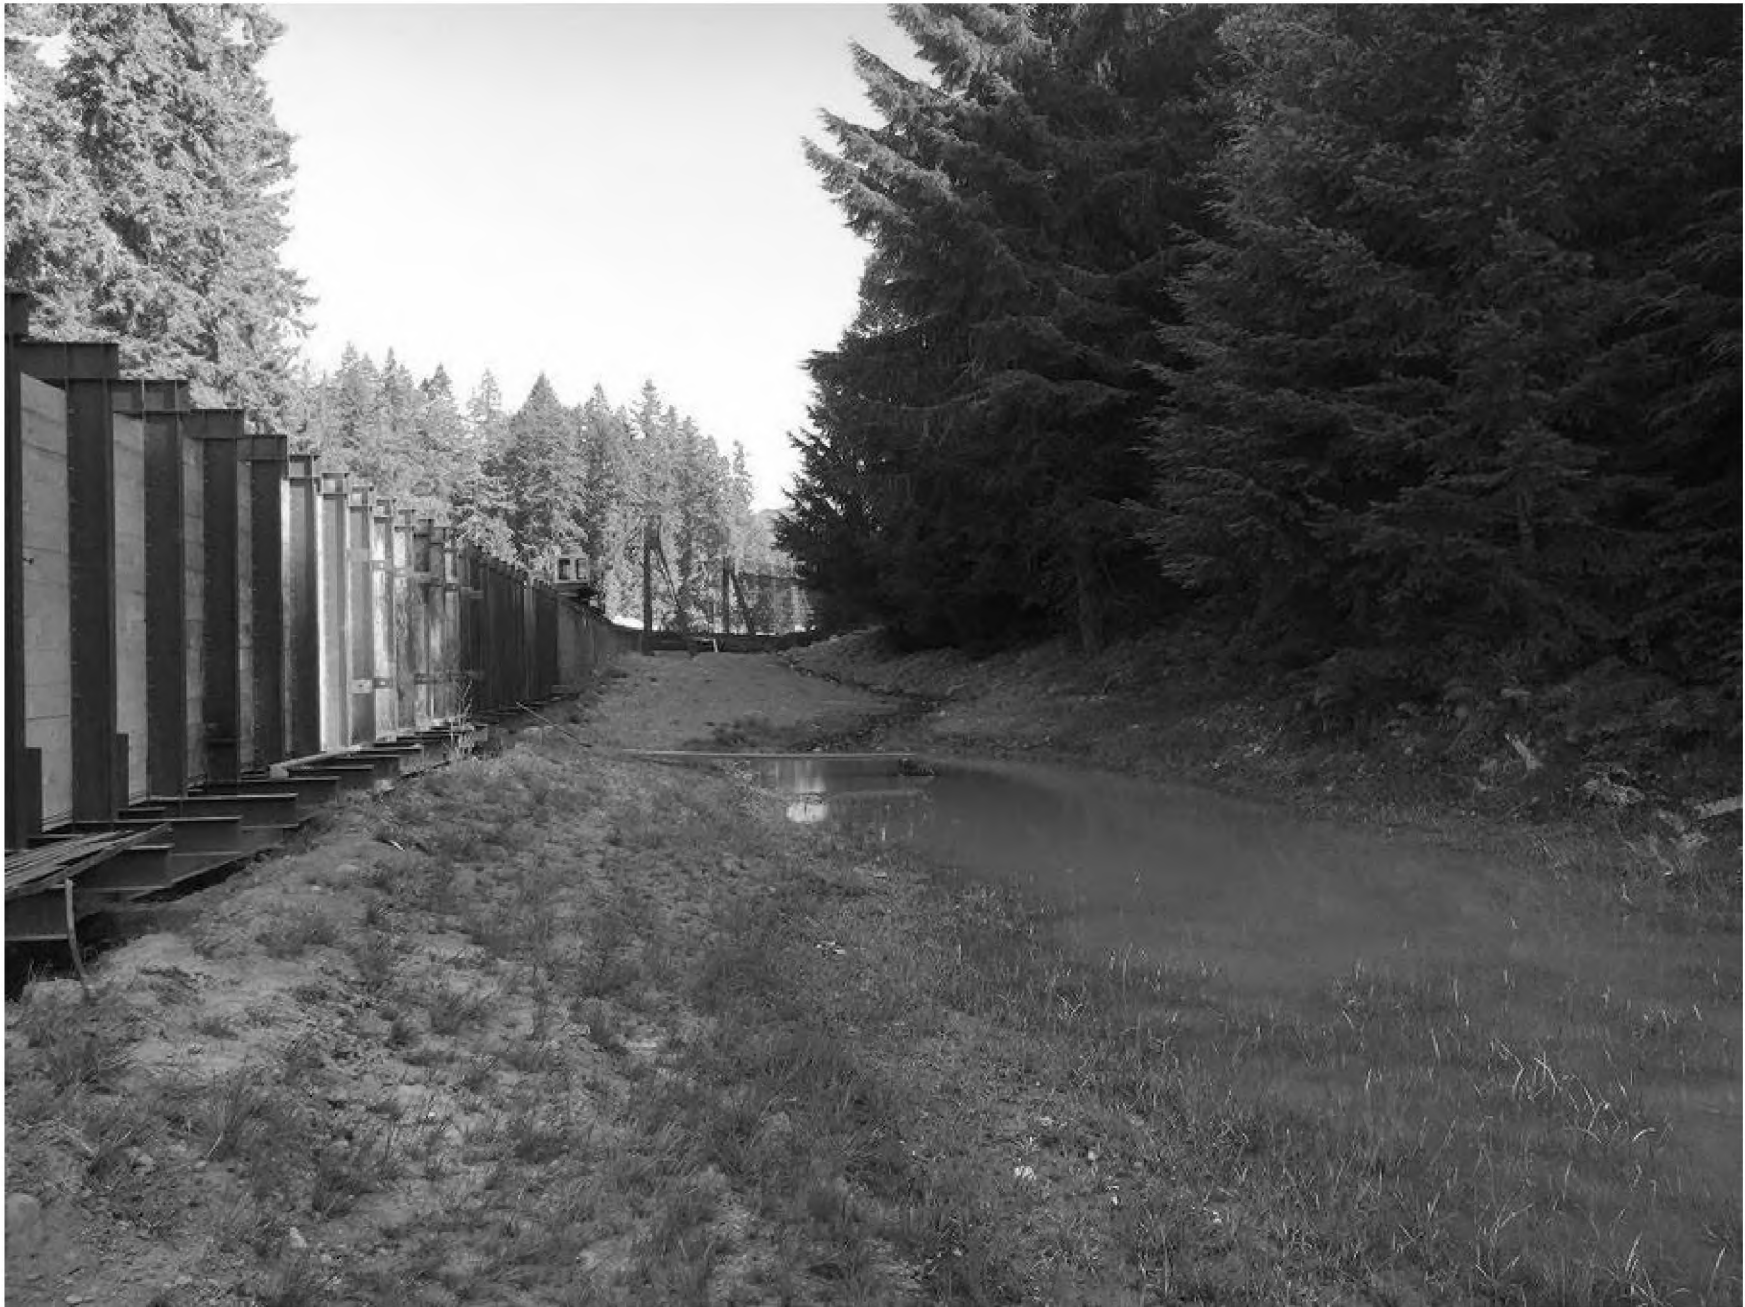
Photo 19

Photo Description: Conveyance ditch discharges into the Sediment Pond with a standpipe and trash rack for overflow to the Stormwater Pond.

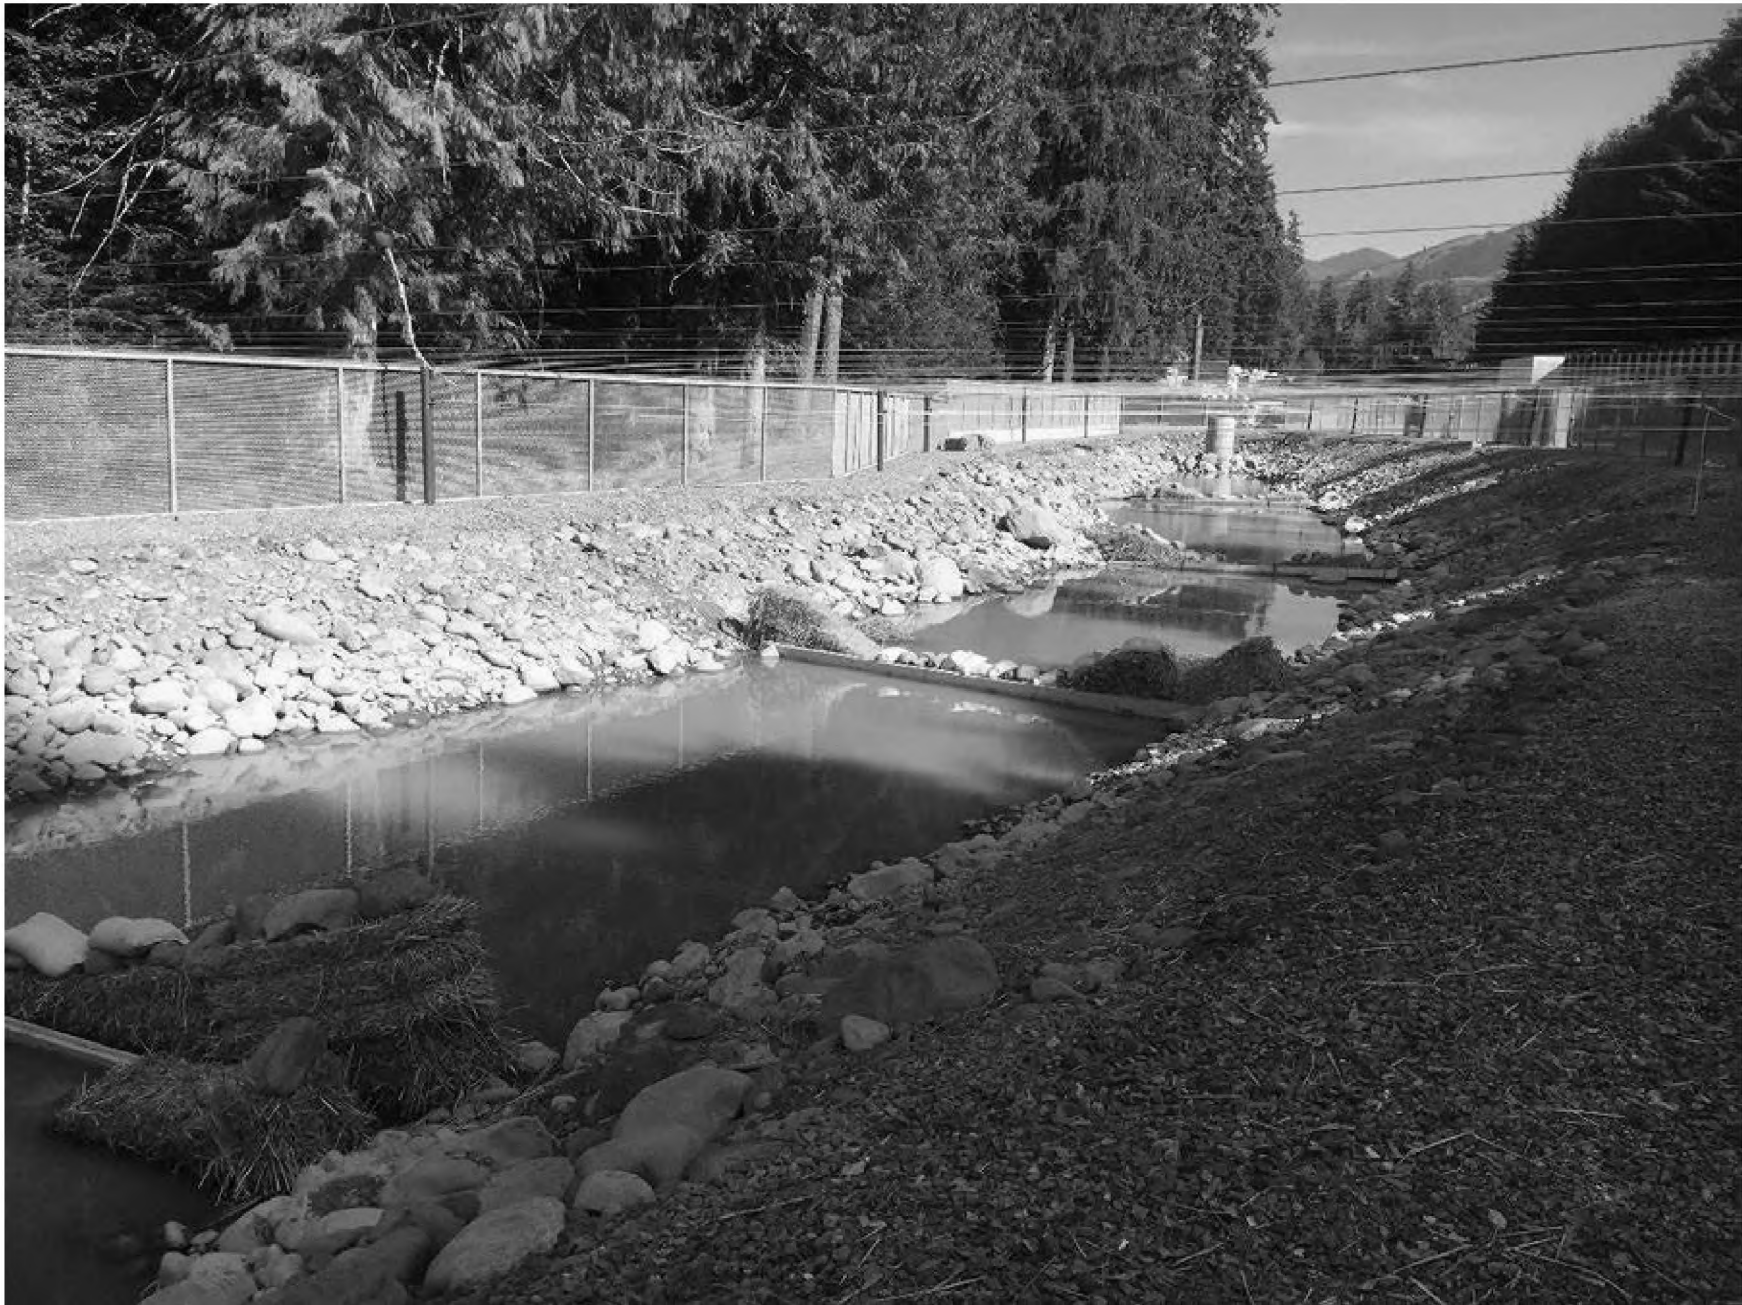
Photo 20

Photo Description: Looking upstream in the Stormwater Pond. Three bays, constructed with straw bales.

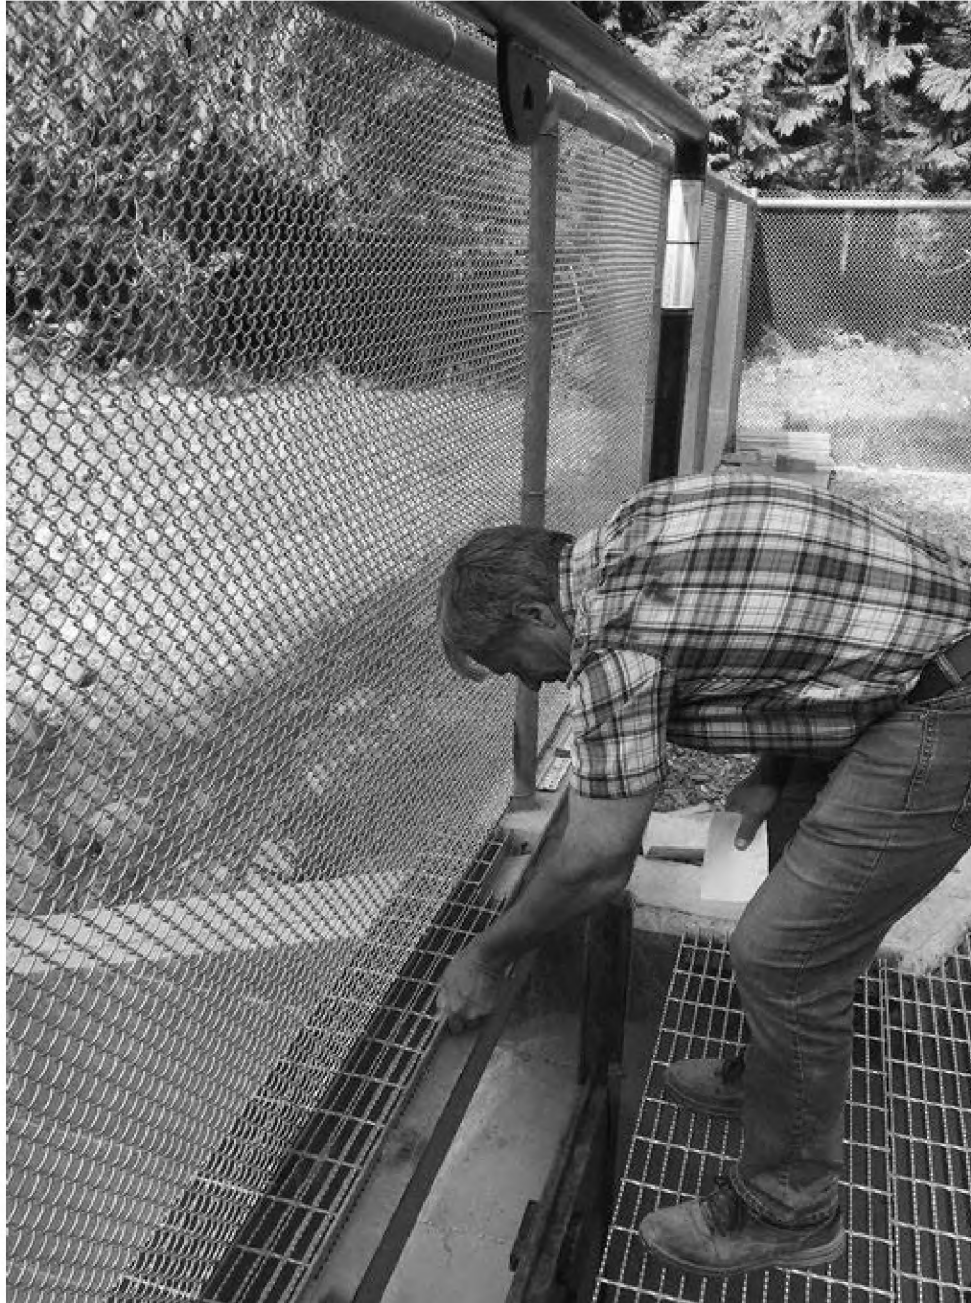
Photo 21

Photo Description: Thom explained the stormwater management system and the outlet of the Stormwater Pond.

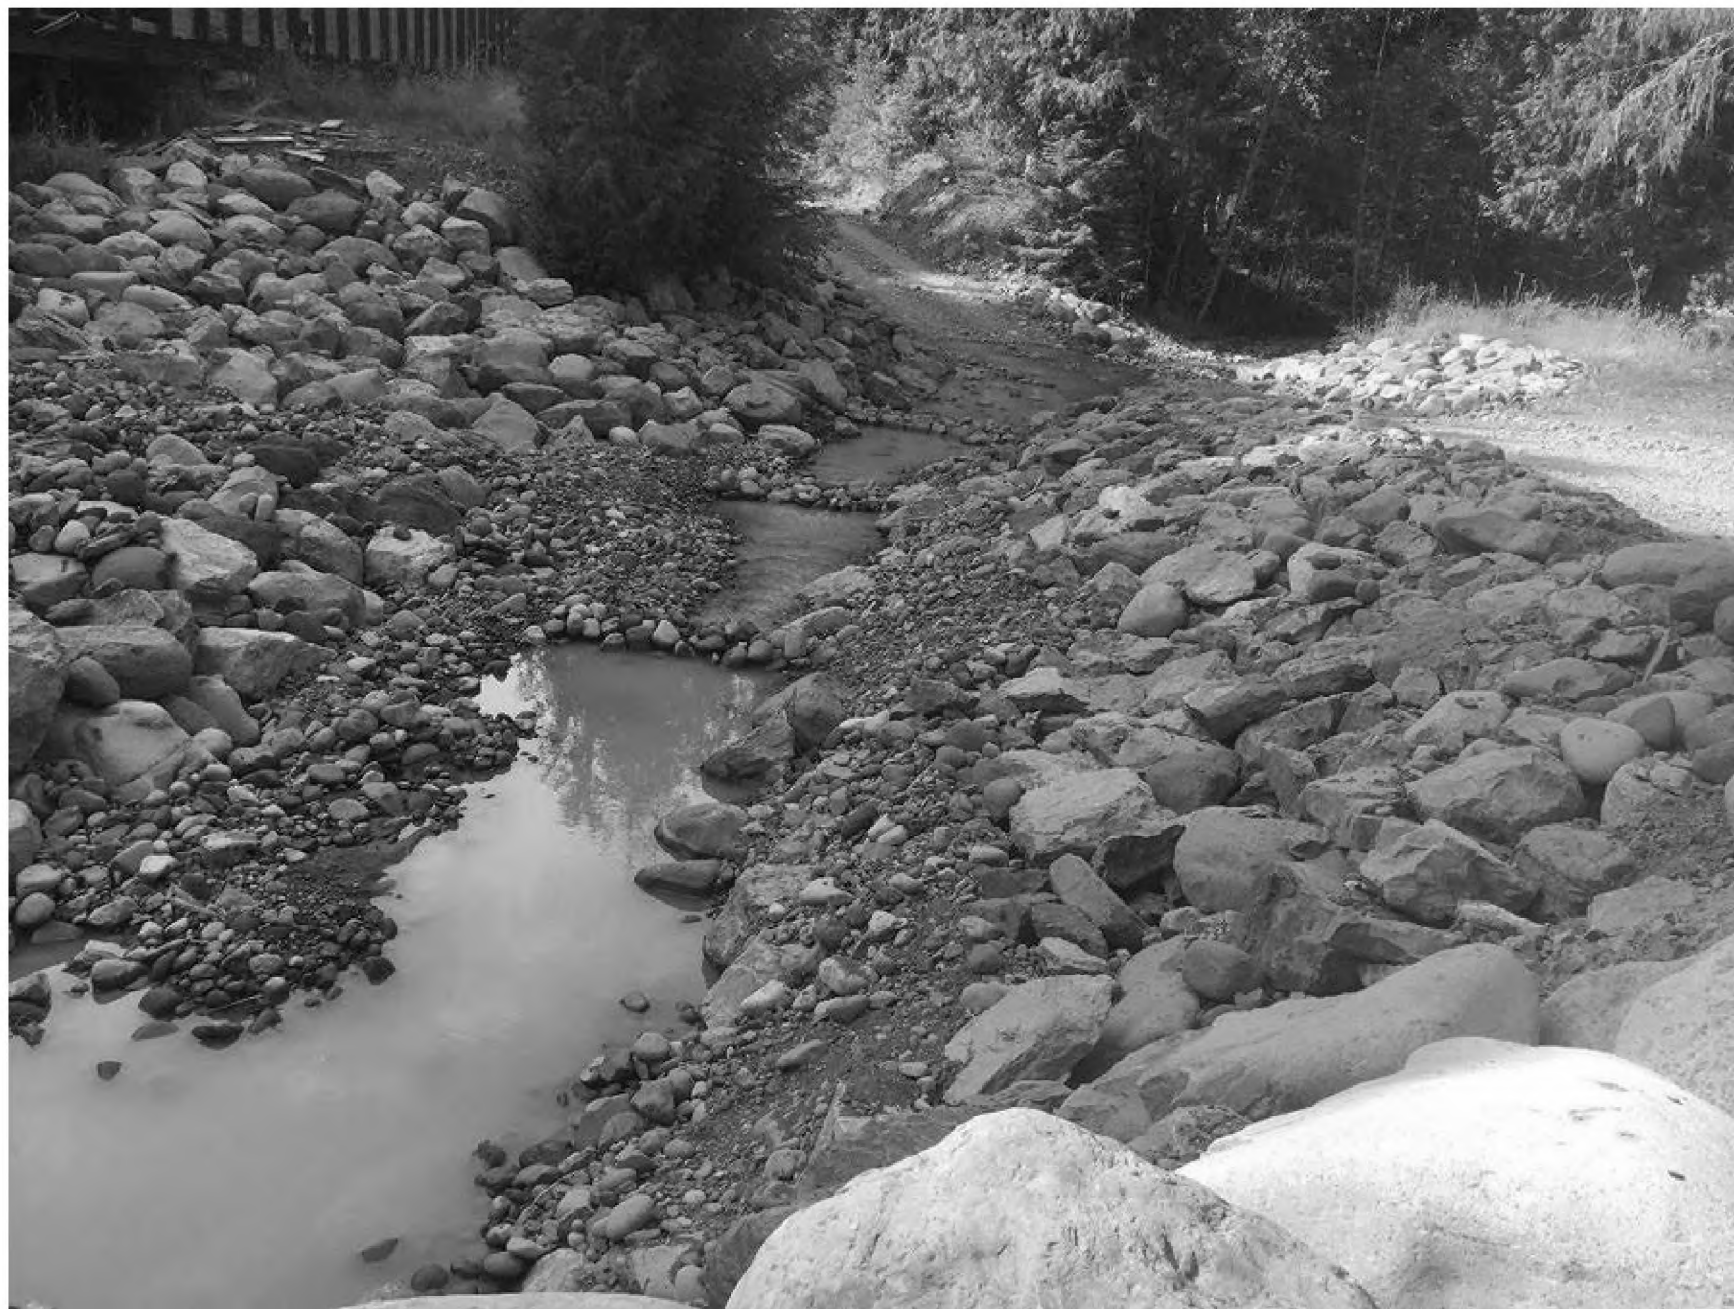
Photo 22

Photo Description: Checkdams directly downstream of the Stormwater Pond (check dams through trees (off the photo – top right) are needed).

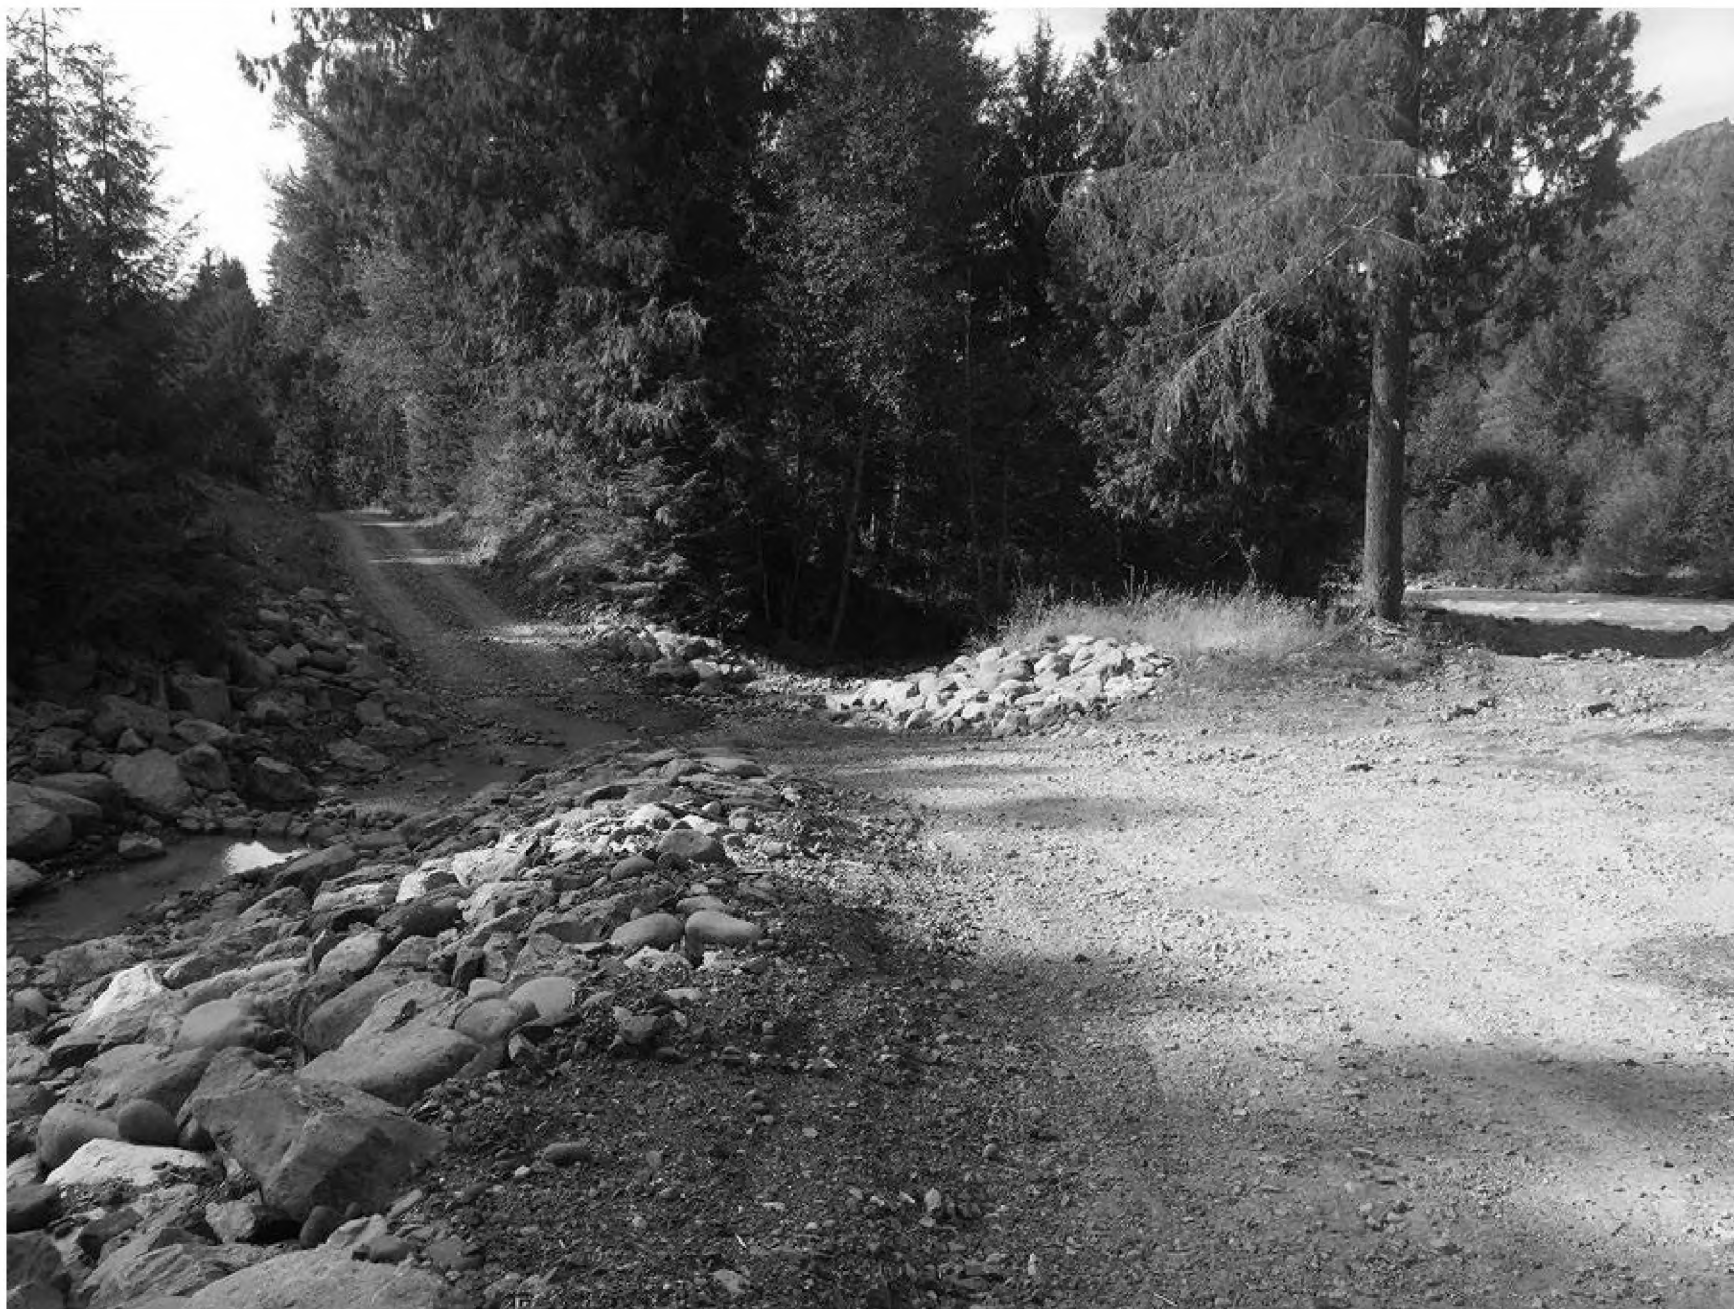
Photo 23

Photo Description: Puyallup River on right side, close to area of sampling point from the Stormwater Pond.

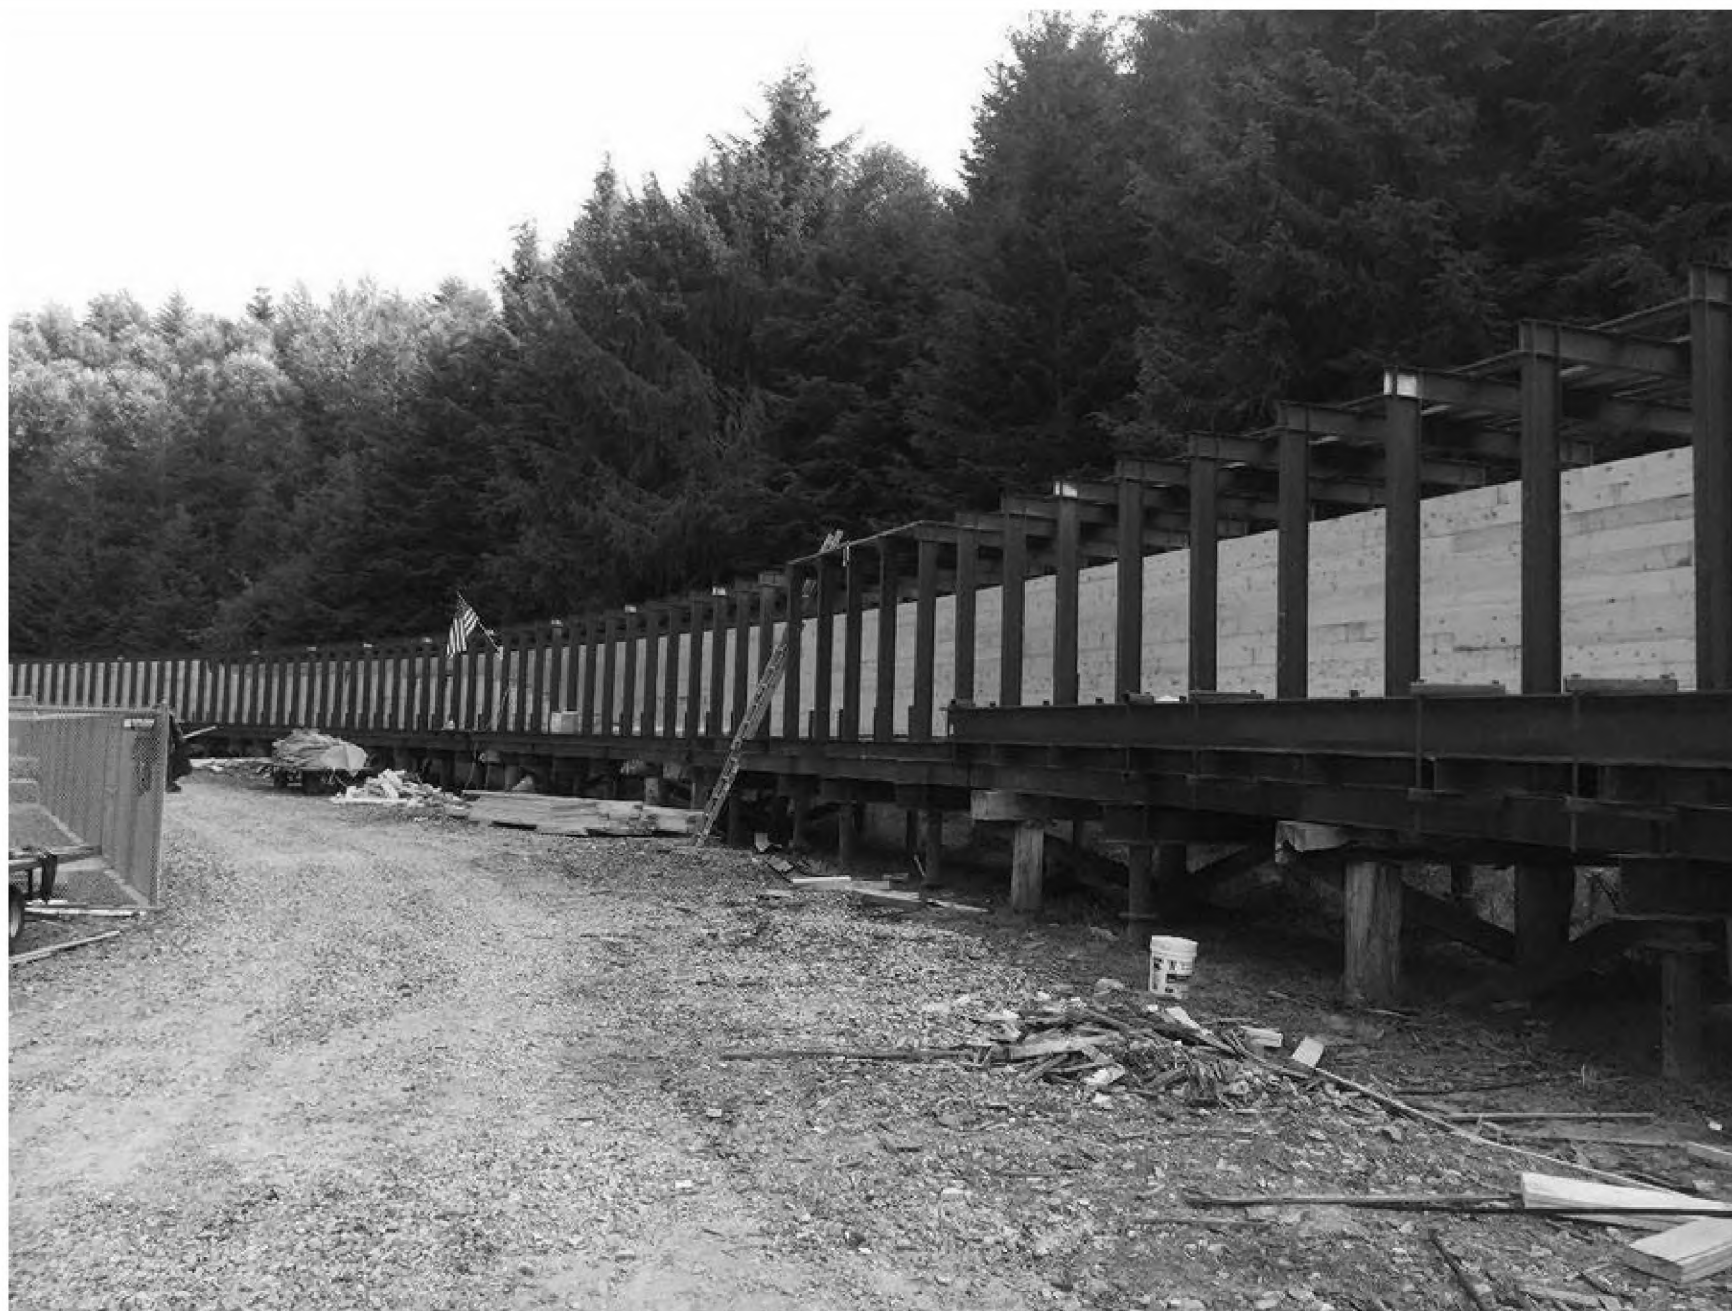
Photo 24

Photo Description: Re-construction of the flume, adjacent to the Sediment Pond (fence on left side of photo).

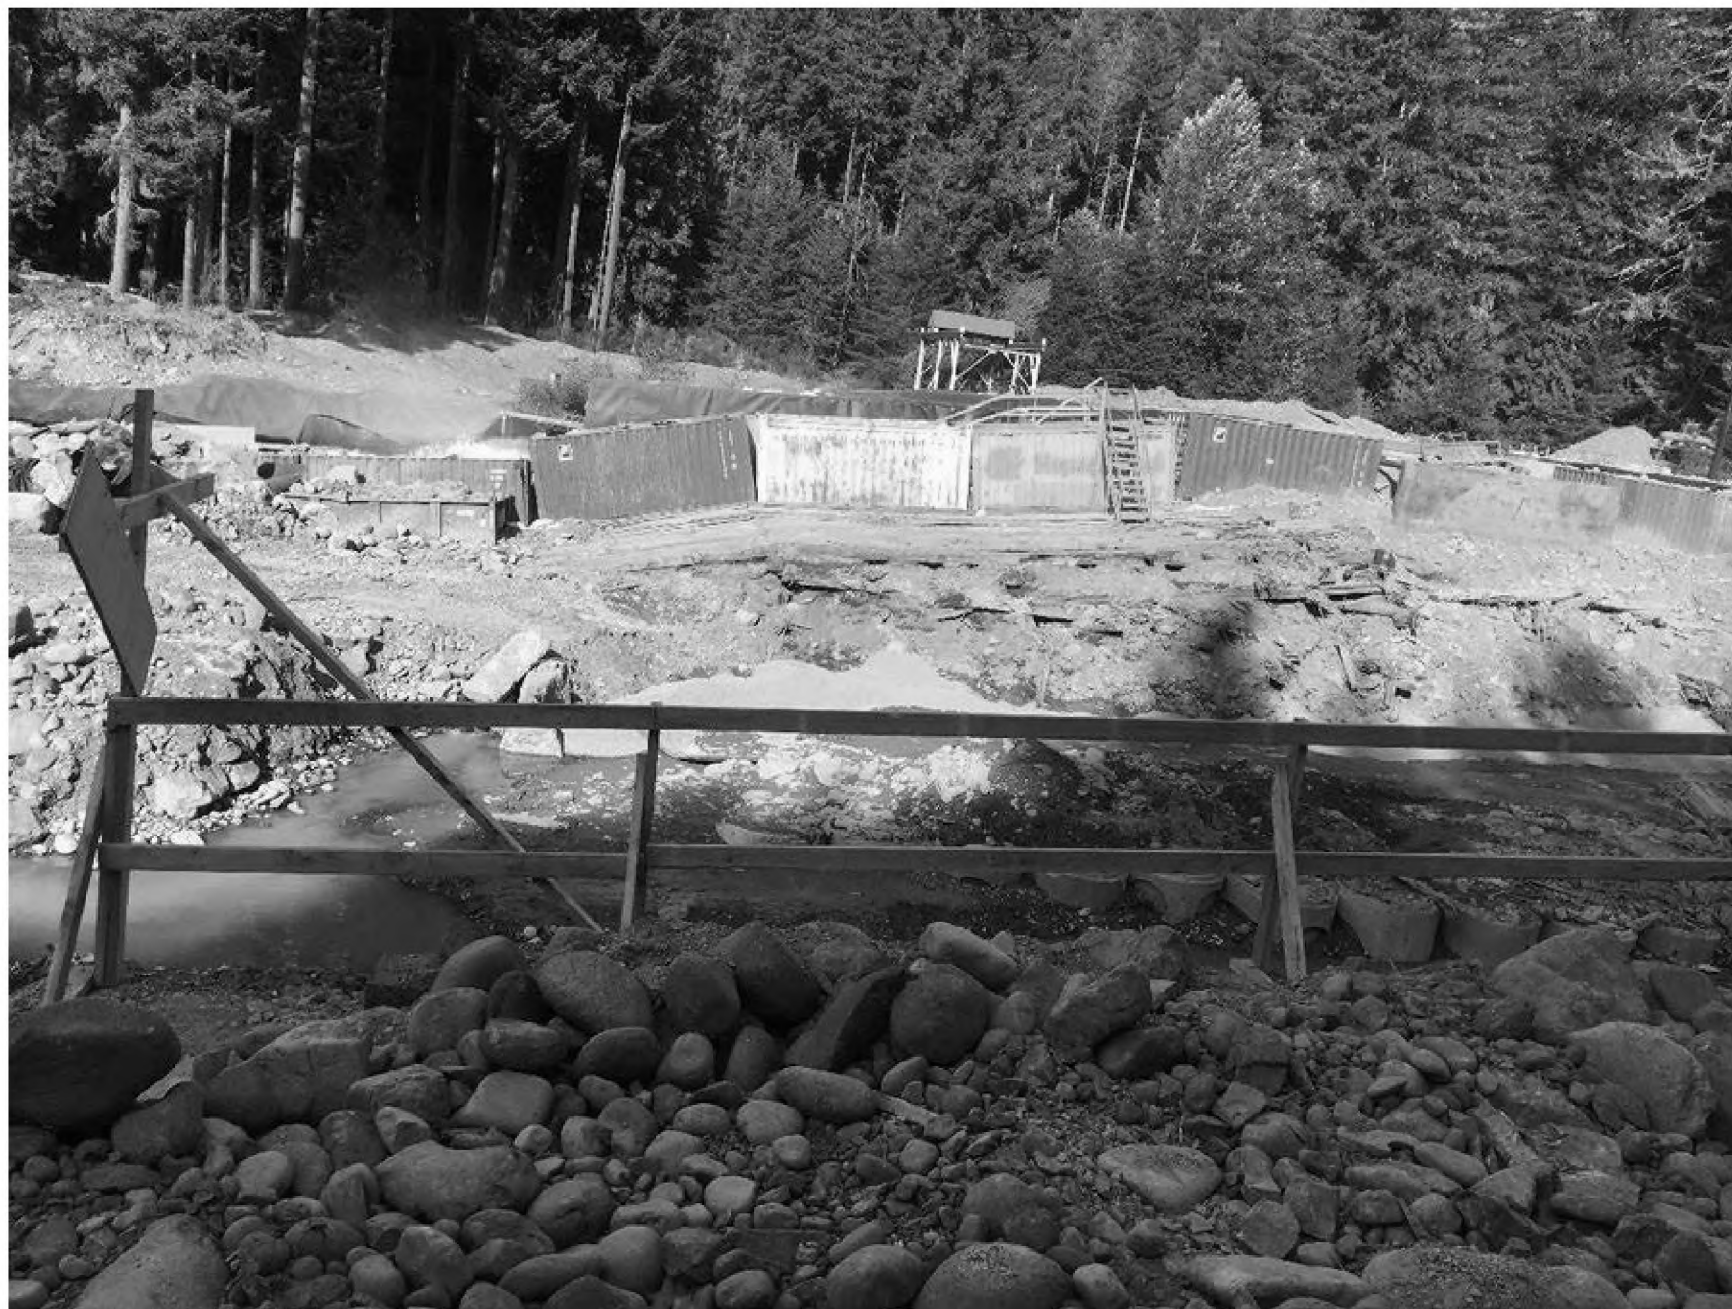
Photo 25

Photo Description: Old wooden diversion dam structure; Puyallup River is flowing through a lined channel behind the storage trailers.
